<b>QUALITY ALERT HR.0001</b>
------------------------------

**Title:** Electronics Cover - 28990

**Part Number:** 28990

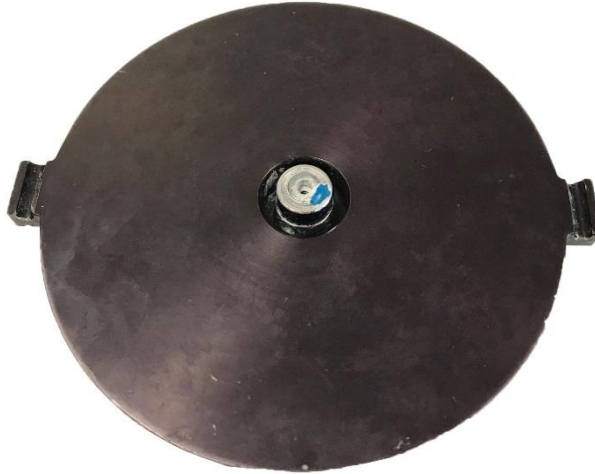
**1. Remove Old Battery Cover**

- a. Unhook both latches and remove old aluminum battery cover

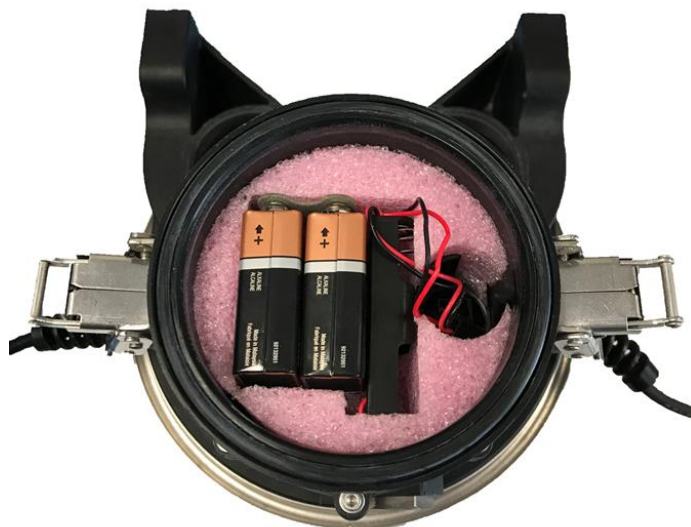
**2. Inspect Battery Compartment**

- a. Clean and lubricate O-ring if necessary
- b. Check for moisture inside battery compartment. If moisture is found, DO NOT DIVE. Please contact Hollis Rebreathers customer support for factory inspection immediately
- c. Check contacts on 9V and 3.6V Lithium batteries inside battery compartment, ensure they are charged and replace if necessary

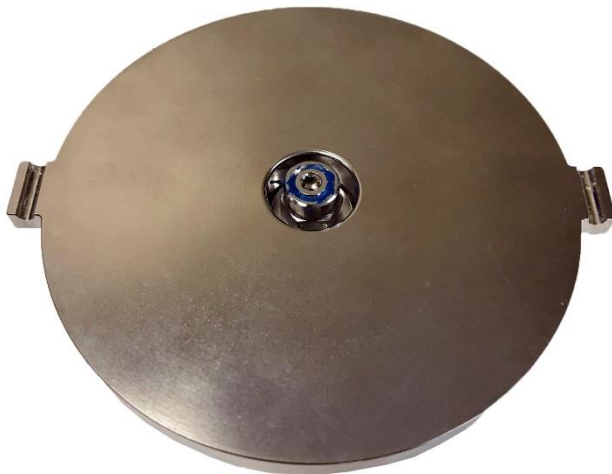
**3. Install New Stainless Battery Cover - 28990S.A**

- a. Secure both latches and ensure battery cover is seated properly
- b. Your Prism 2 electronics cover is now upgraded
- c. If you have any additional questions or concerns, please contact [service@hollisrebreathers.com](mailto:service@hollisrebreathers.com) or call 385.770.7430
